Weather Station Maintenance in Southwest Alaska Network Parks

Summary for the 2013 Hydrologic Year

Natural Resource Data Series NPS/SWAN/NRDS—2013/592

Chuck Lindsay

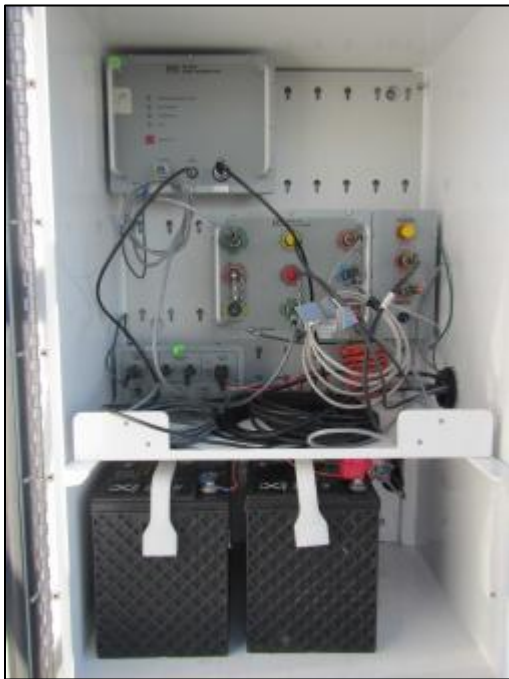
Figure 5. Chimgit Mountain RAWS – Inside of instrument enclosure photographed before departure.

Maintenance of Chigmit Mountains weather station was done on the same day as maintenance on Fourpeaked weather station. A round-trip helicopter flight was made from Homer with a refueling stop in Port Alsworth (at Lake and Pen Air). The station had been badly damaged by rime ice (Figures 2 and 3) and the 20-ft wind sensor mast had broken and both wind sensors were wrecked. This mast was replaced with a new one that was reinforced by welding a smaller diameter aluminum pipe inside the mast in order to reinforce the junction which had broken. All guy-wires and associated hardware were also replaced. The AT-RH sensor, WS sensor and cable, WD sensor and cable were replaced. A WD sensor direction test was done. The rain count for the tipping bucket was zeroed, and a tipping bucket test was done. All data in the data logger were downloaded to send to the WRCC in order to update the archive. The SD sensor was replaced with a Campbell Scientific SR50 SD sensor, which was rehabbed with new transducer plates and desiccant. Data logger program CHMO_DLP_SR50.prg was edited to zero the SD sensor. Snow depth was zeroed to an average reading of -0.5 inches to account for fluctuation without reporting misleading snow depth readings. In stark contrast to June of 2012, there was no snow present directly at the station at the time of maintenance. All bolts on the station were checked and tightened if loose and all cables were zip-tied. Station observations and GOES transmission quality were checked before departure. Observations and transmissions were verified from the WFMI website and relayed by satellite phone. Before departure the station was photographed from eight directions (every 45°, Figure 4) and the inside of the instrument enclosure (Figure 5) was also photographed.

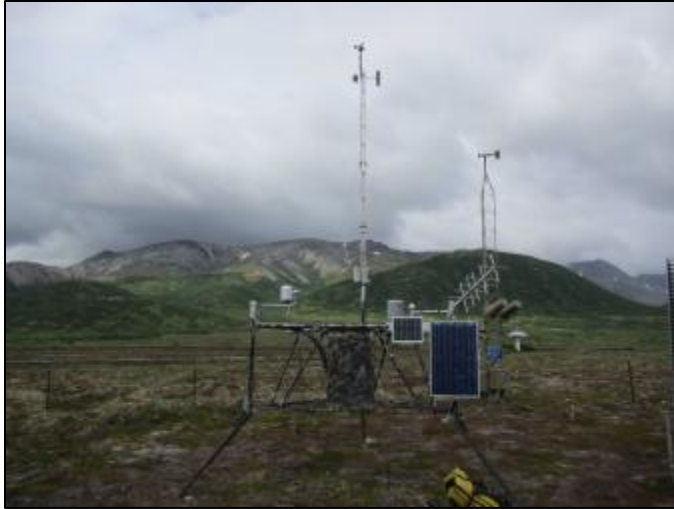
Figure 6. Contact Creek RAWS – Station after maintenance photographed from south. The Climate Reference Network station that was installed in August 2012 is visible in the background.

Access to the Contact Creek weather station was by park wheel plane from King Salmon. The station was in good shape. The AT-RH sensor was replaced and the SD sensor was replaced with a Campbell Scientific SR50A SD sensor, which had been rehabbed with new transducer plates and desiccant. The rain count for the tipping bucket was zeroed and a tipping bucket test was done. All data in the data logger were downloaded to send to the WRCC in order to update the archive. Data logger program COCR_DLP_SR50A.prg was edited to zero the SD sensor. Snow depth was zeroed to an average reading of -0.5 inches to account for fluctuation without reporting misleading snow depth readings. Observations and transmissions were verified from the WFMI website and relayed by satellite phone. All bolts on the station were checked and tightened if loose and all cables were zip-tied. Before departure the station was photographed from eight directions (every 45°; Figure 6). The electric fence that surrounds the Climate Reference Network station and the RAWS was maintained. Upon arrival the gate was found open.

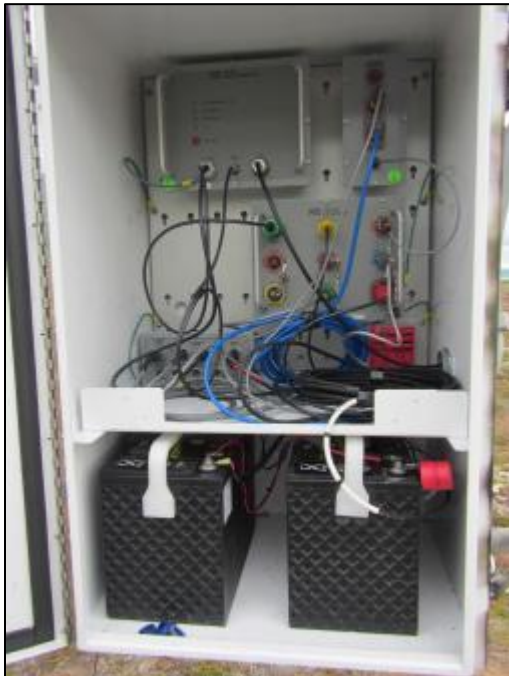
Figure 9. Contact Creek RAWS – The inside of instrument enclosure photographed before departure. Note Campbell Scientific power cable with white labeling leading toward 100 Ah batteries.

light conditions. The separate 35 Ah battery and charge controller were removed and the camera was directly connected to the two 100 Ah batteries that charge the weather station (Figure 8).

The inside of the instrument enclosure (Figure 9) was also photographed before departure.

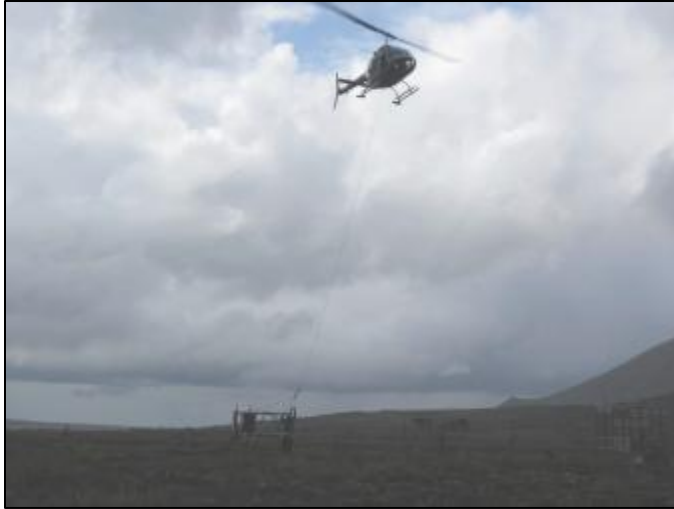
Figure 10. Contact Creek RAWS – Egli Air Haul helicopter slings the weather station tower to Three Forks.

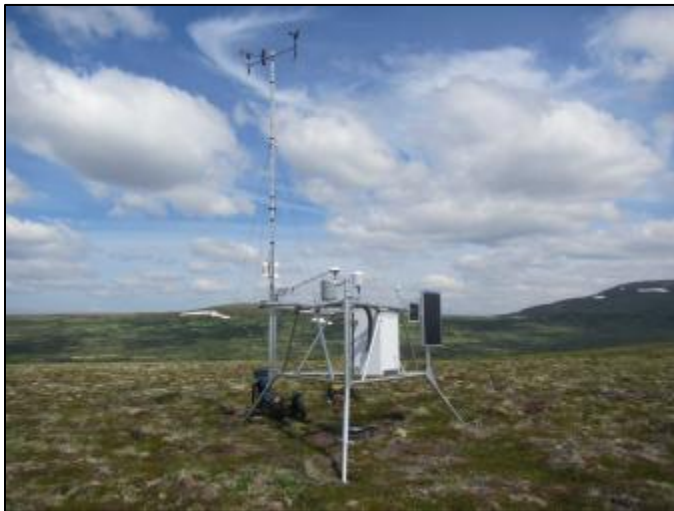
Figure 13. Coville RAWS – Station after maintenance photographed from southwest.

Access to the Coville weather station was by USFWS float plane (NPS pilot) from King Salmon (Figure 12). The station was in great shape. The AT-RH sensor was replaced and the SD sensor was replaced with a Campbell Scientific SR50A SD sensor, which had been rehabbed with new transducer plates and desiccant. The SR sensor was replaced because there had been some anomalous data spikes during spring. The SDI expansion port was also replaced because it wasn't clear if the expansion port or the SR sensor were causing the problem. The rain count for the tipping bucket was zeroed and a tipping bucket test was done. All data in the data logger were downloaded to send to the WRCC in order to update the archive. Data logger program COVI_DLP_SR50A.prg was edited to zero the SD sensor. Snow depth was zeroed to an average reading of -0.5 inches to account for fluctuation without reporting misleading snow depth readings. Observations and transmissions were verified from the WFMI website and relayed by satellite phone. All bolts on the station were checked and tightened if loose and all cables were zip-tied. Before departure, the station was photographed from eight directions (every 45°; Figure 13) and the inside of the instrument enclosure was also photographed (Figure 14).

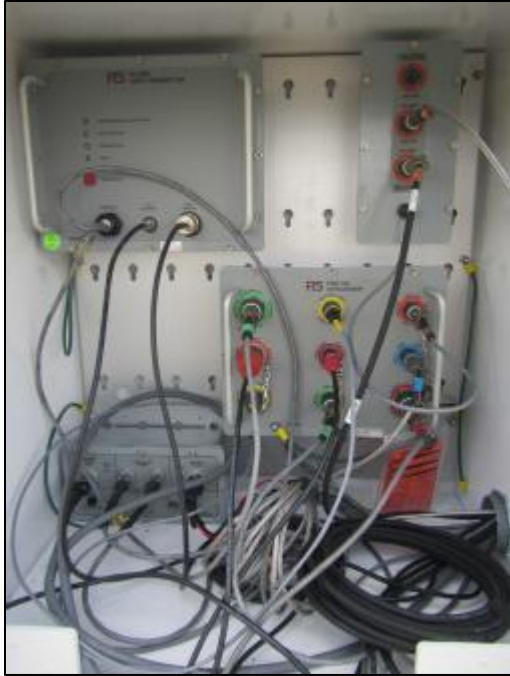
Figure 14. Coville RAWS – Inside of instrument enclosure after maintenance.

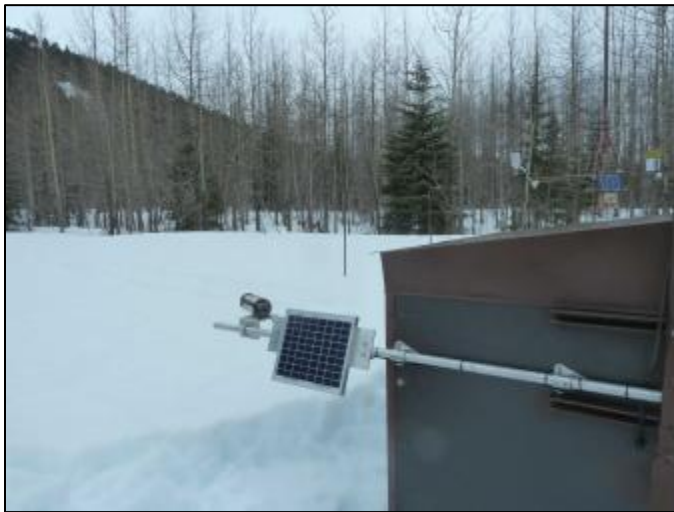
Figure 17. Exit Glacier phenocam – Campbell Scientific time lapse camera and 10 W solar panel mounted to the equipment shelter at the Exit Glacier SNOTEL.

A Campbell Scientific CC5MPX digital camera was mounted to the equipment shelter at the Exit Glacier SNOTEL site. In order to mount the camera, one inch aluminum pipe was attached to the shelter using speed-rail fittings (Figure 17). The camera was equipped with a 16 GB SD card and programmed to acquire 13 JPG-format photos/day. The camera is powered by a 35 Ah sealed battery that is stored inside the equipment shelter (Figure 18) and a 10 W solar panel.

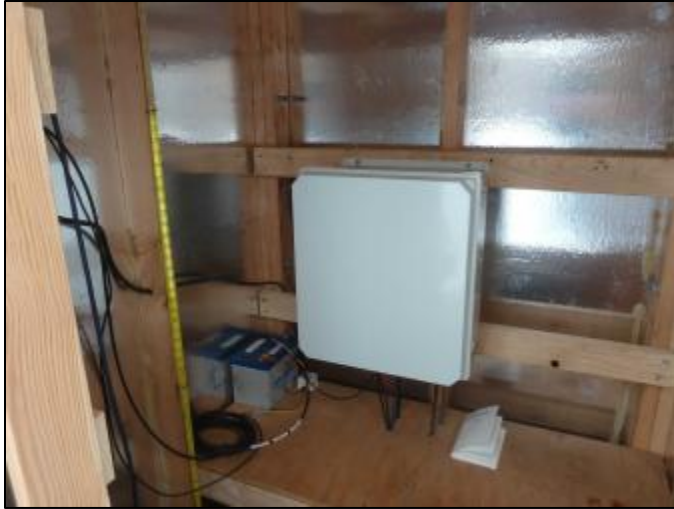
Figure 18. Exit Glacier phenocam – 35 Ah battery and charge controller inside the equipment shelter at the Exit Glacier SNOTEL.

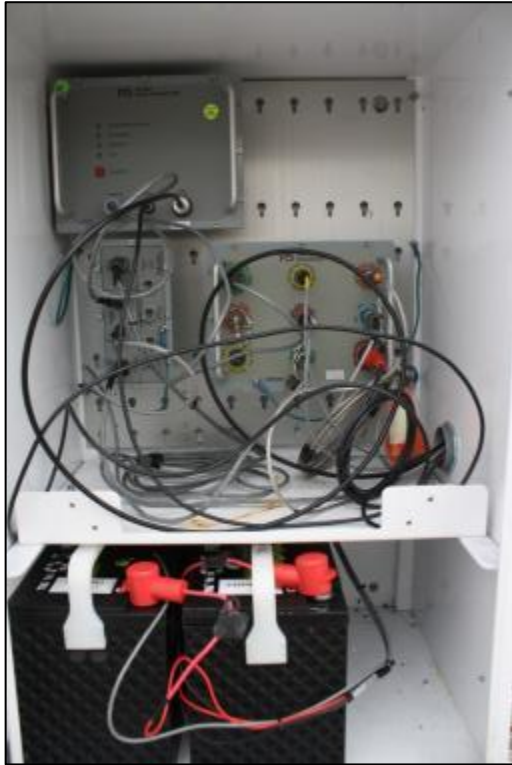
Figure 24. Fourpeaked RAWS – Inside of instrument enclosure after maintenance.

Access to the Fourpeaked weather station was by helicopter from Homer. The station appeared to be in good condition with no visible damage, but it was not working. Station stopped transmitting on September 2, 2012. Upon arrival there were no fault lights indicated on the GOES transmitter. Problems were experienced communicating with the data logger using FTS toolbox. The error message “Error 301: Unable to wake device” was repeatedly received and communications were never established. Thus data was never retrieved. The data logger, GOES transmitter, power manager, GOES antenna (oriented to 159 degrees true and inclination of +16 degrees) and cable, and GPS antenna and cable were all replaced because it wasn’t clear which component was faulty. It was clear that the data logger wasn’t working, but it wasn’t obvious what caused it to fail. This problem was previously experienced on June 16, 2012 and the station was subsequently repaired on July 17, 2012. Due to the cost of accessing this station everything that might have contributed to the problem was replaced. Battery voltage was good and both batteries had been replaced on June 7, 2012 so they were not replaced during this visit. Some corrosion was present on the base of the power manager (Figure 22) and on the GOES antenna where the antenna elements are attached (Figure 23). The solar radiation sensor was also replaced because the sensor had a short cable and, because its cable couldn’t be routed properly, it was vulnerable to damage by storms and wildlife. The replacement sensor cable has an armored housing. Station observations and GOES transmission quality were checked before departure with FTS support. Observations and transmissions were verified from the WFMI website by NIFC staff and relayed by satellite phone. Before departure the station was photographed from eight directions (every 45°) and the inside of the instrument enclosure (Figure 24) was also photographed.

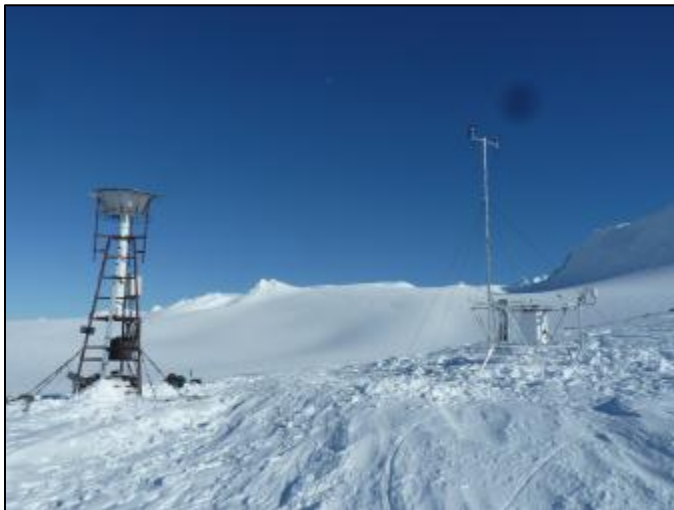
Figure 29. Harding Icefield RAWS – Station after maintenance viewed from the northwest.

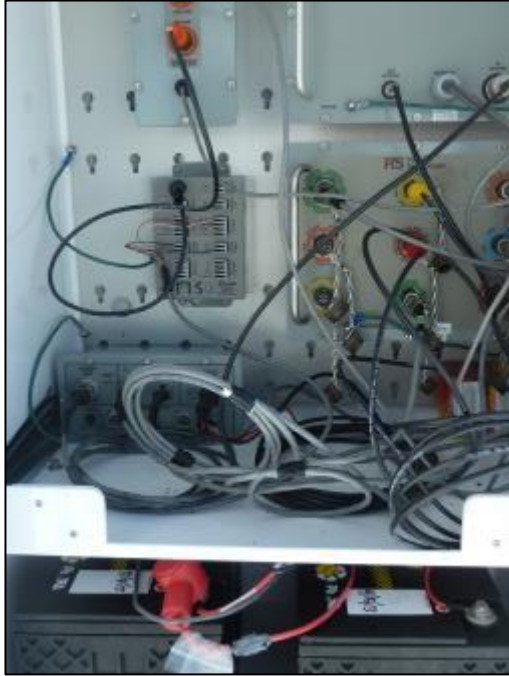
Figure 30. Harding Icefield RAWS – Inside of the instrument enclosure after maintenance. Note the wiring configuration used on the SDI-AM module.

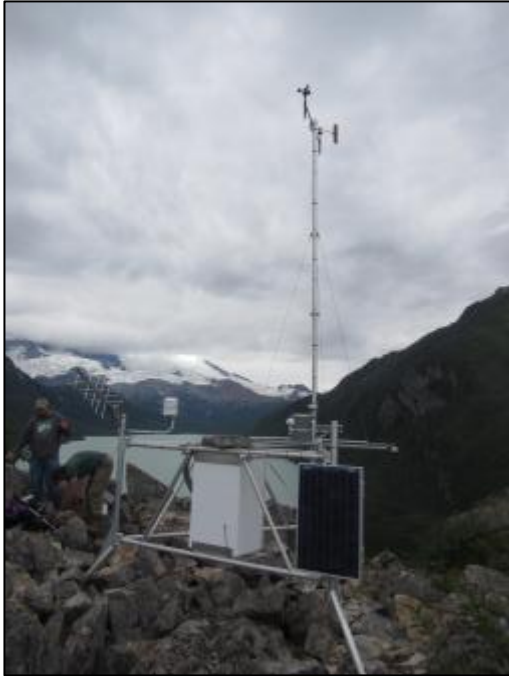
Figure 33. Hickerson Lake RAWS – The station after maintenance viewed from the southeast. Hickerson Lake and the flanks of Iliamna Volcano are visible in the background.

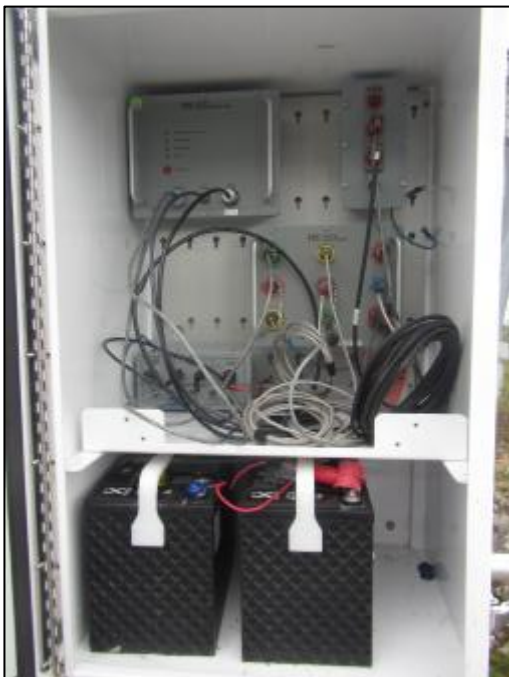
Figure 34. Hickerson Lake RAWS – The inside of the instrument enclosure after maintenance.

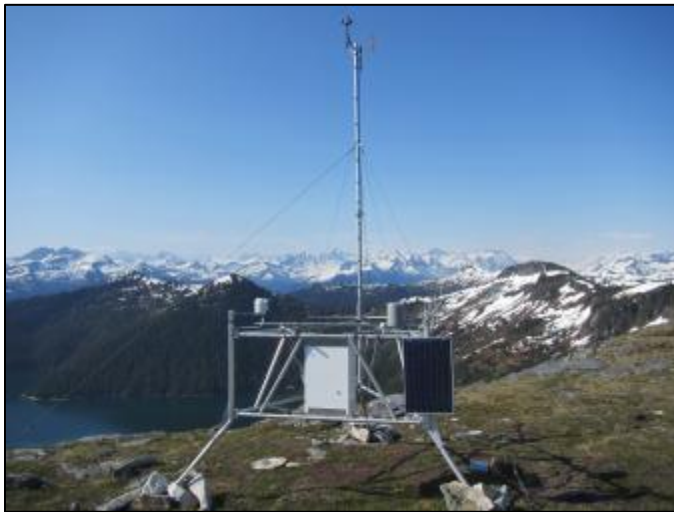
Figure 38. McArthur Pass RAWS – The station after maintenance viewed from the southeast.

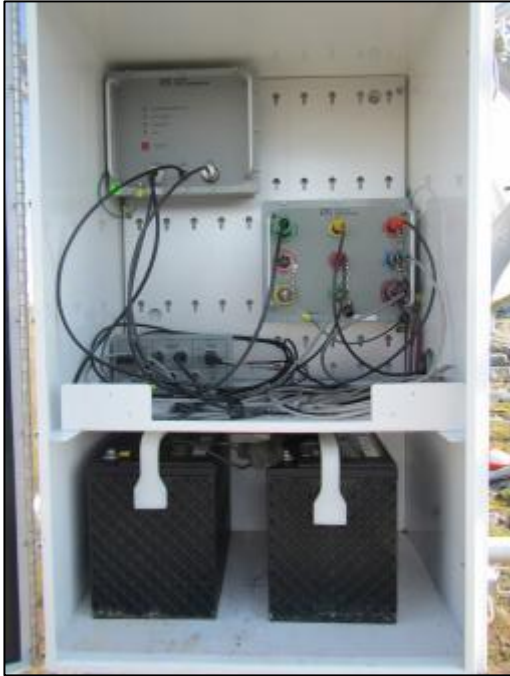
Figure 39. McArthur Pass RAWS – Inside the instrument enclosure after maintenance.

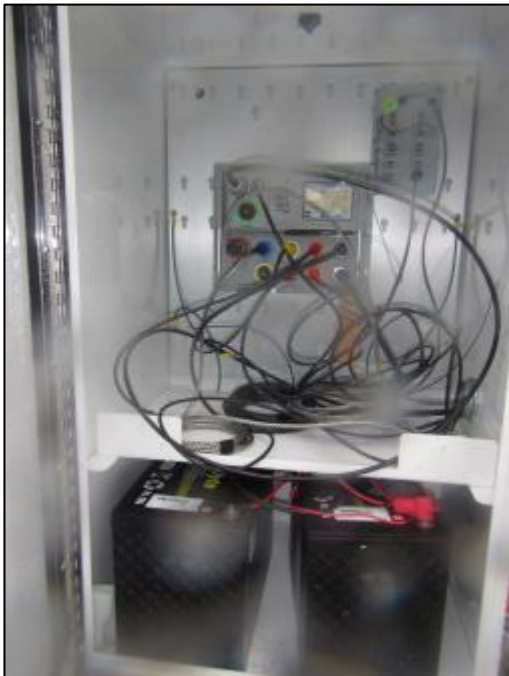
Figure 43. Pedersen Lagoon RAWS – Inside of the instrument enclosure after maintenance.

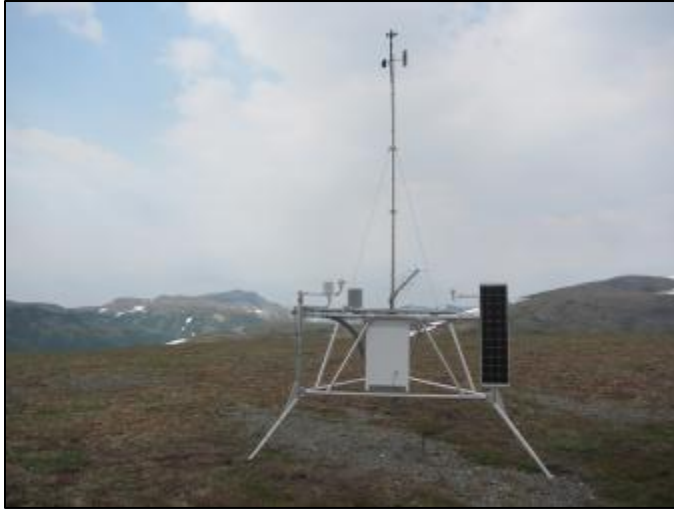
Figure 46. Pfaff Mine RAWS – Station after maintenance viewed from the south.

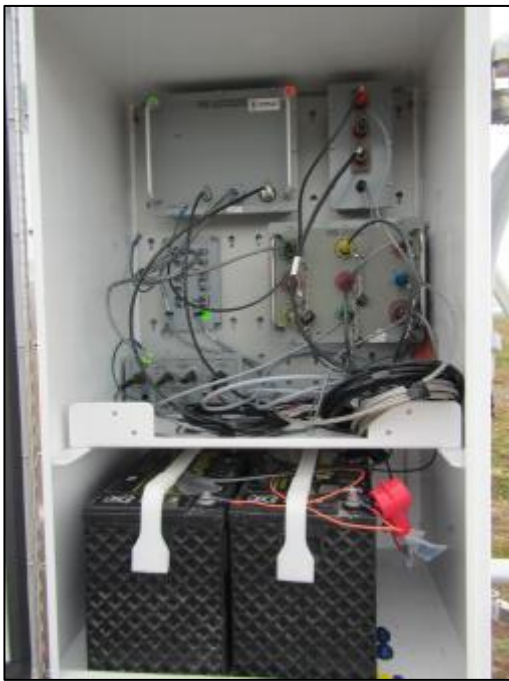
Figure 47. Pfaff Mine RAWS – Inside of instrument enclosure photographed just before departure.

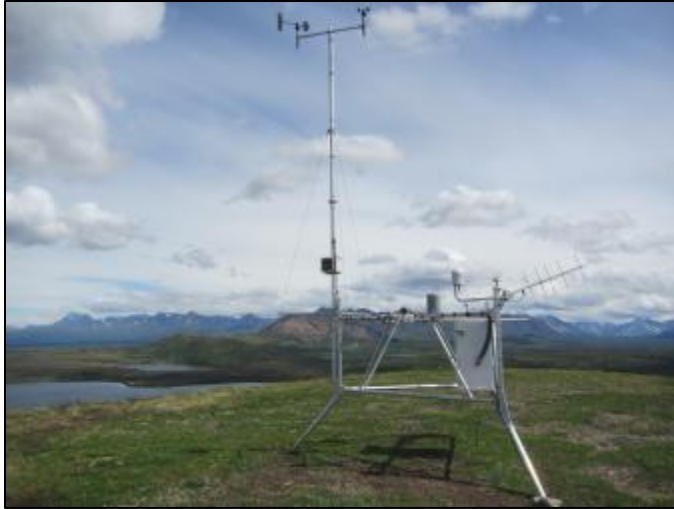
Figure 57. Snipe Lake RAWS – Station after maintenance (viewed from the northwest).

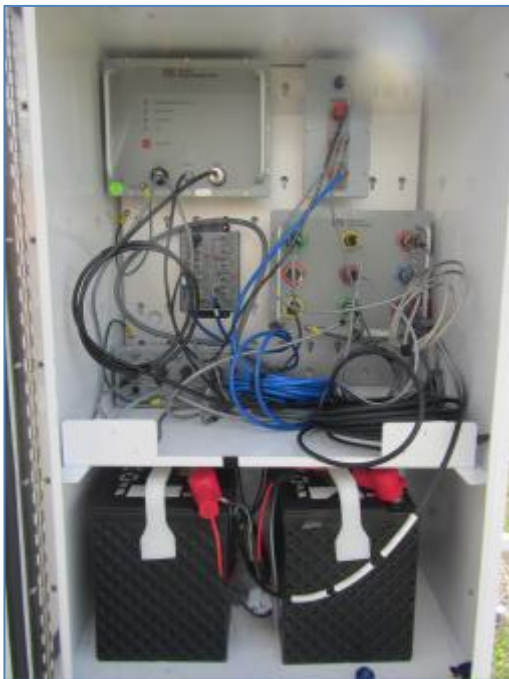
Figure 58. Snipe Lake RAWS – Inside of instrument enclosure after maintenance. Note Campbell Scientific power cable with white labeling leading toward 100 Ah batteries.

The newer Campbell Scientific time lapse camera (Figure 60) was also maintained. The 16 GB SD card was exchanged for an empty one and the tiny desiccant packs were replaced. The camera collected 13 JPG-format photos/day between June 14, 2012 and December 20, 2012 when the camera apparently stopped working. Battery voltage was <2 V. It is assumed the camera did not switch into a low power state and therefore drained the battery during winter low-light conditions. The separate 35 Ah battery and charge controller were removed and the camera was directly connected to the two 100 Ah batteries that charge the weather station.

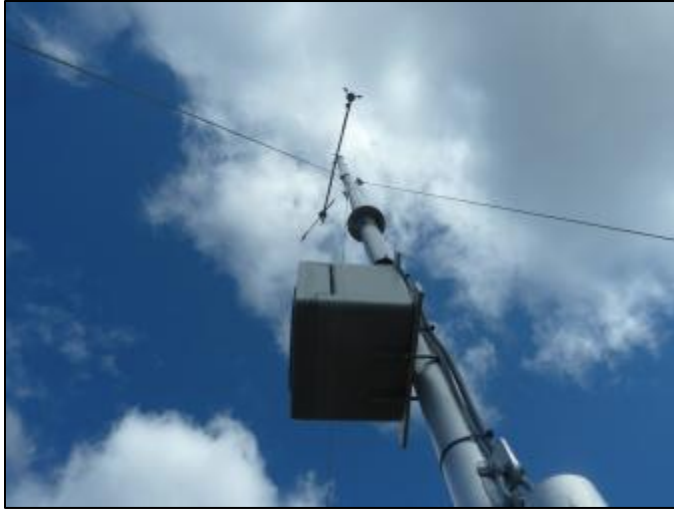
Figure 59. Snipe Lake RAWS – Harbortronics phenocam.

The Harbotronics time lapse camera (Figure 59) was maintained. The 32 GB SD card was exchanged for an empty one and the desiccant packs were replaced. The camera collected five RAW-format photos/day between August 7, 2012 and June 20, 2013. The intervalometer programming was not changed. Before departure a thin film of silicone grease was applied to the gasket on the housing door with an irrigation to help maintain a seal.

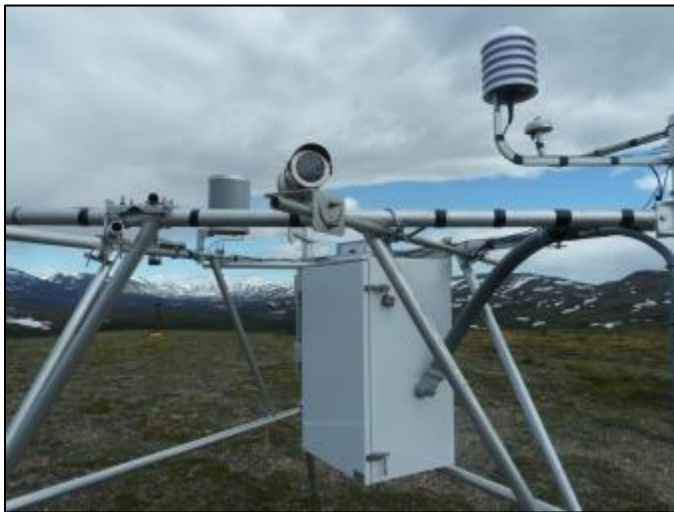
Figure 60. Snipe Lake RAWS – Campbell Scientific phenocam.

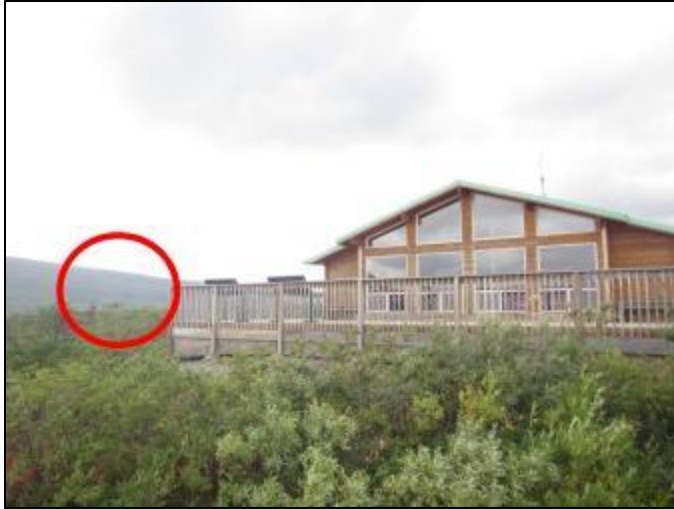
The new weather station was set up on the hill slope immediately southwest of the NPS cabin at Three Forks (Figure 61). The station is equipped with the standard suite of AT-RH, RG-TB, WS, WS, SR, and SD sensors (Figure 62). Data logger program THFO_DLP_SR50A.prg was uploaded to the 12S data logger. SD was zeroed to an average reading of -0.5 inches to account for fluctuation without reporting misleading snow depth readings. The inside of the instrument enclosure is shown in Figure 63. The station was camouflaged using spray paint (Figure 62). The station was anchored to the ground using two three foot long steel stakes driven through the tower feet. It is recommended that additional anchors (guy-wires and duckbill anchors) be installed in the future.

Figure 61. Three Forks RAWS – The weather station (circled) is visible to the left of the Three Forks cabin.

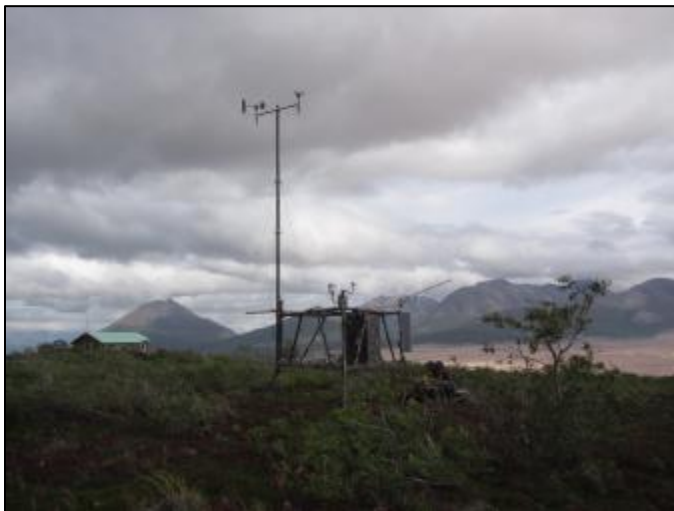
Figure 62. Three Forks RAWS – The weather station after set up (viewed from the southwest). The station, with the exception of the sensors, was camouflaged using spray paint.

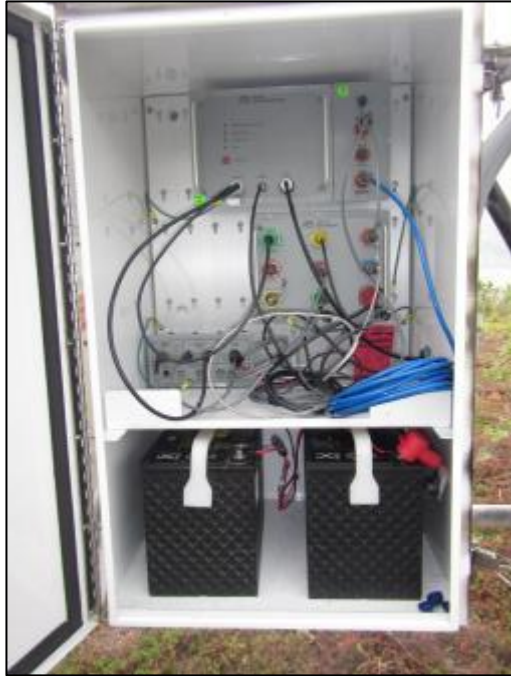
Figure 63. Three Forks RAWS – Inside of the instrument enclosure after set up.
